918 Panel Watercourse Stability and Geomorphological Assessment Clarence Colliery

Clarence Colliery Pty Ltd

14 January 2026

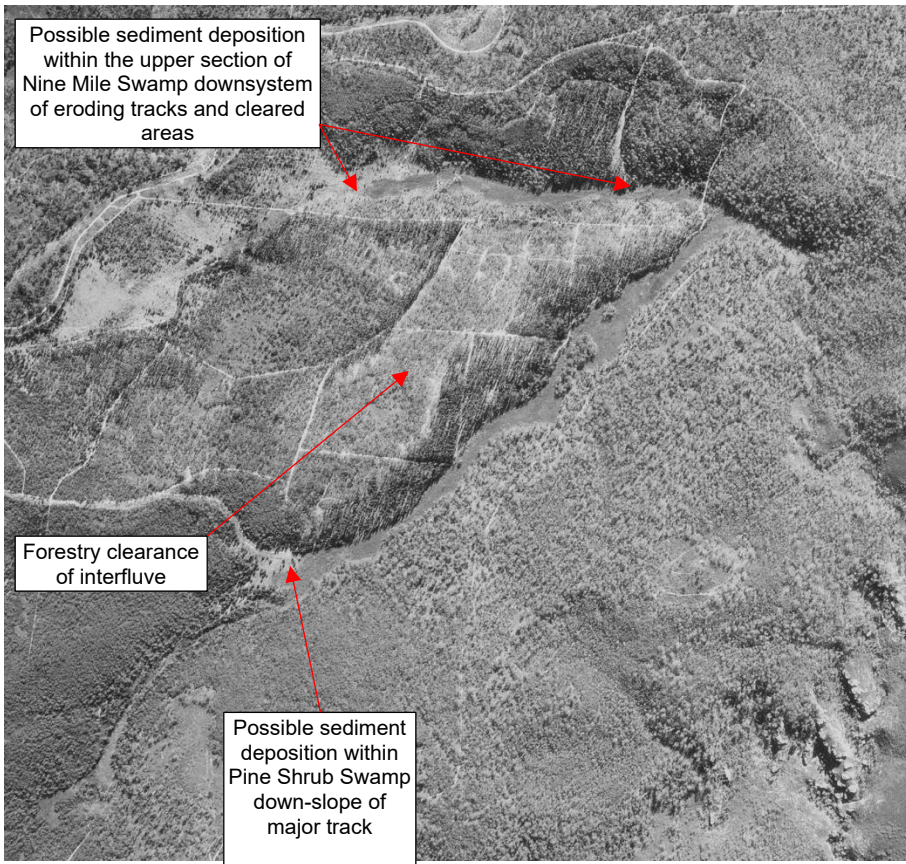
<p>Possible sediment deposition within the upper section of Nine Mile Swamp downsystem of eroding tracks and cleared areas</p> <p>Forestry clearance of interflue</p> <p>Possible sediment deposition within Pine Shrub Swamp down-slope of major track</p>	<p>May 1969</p> <p>Interflues between the upper section of Nine Mile Swamp and Pine Shrub Swamp, and plateau / ridgetops show considerable impact from forestry and tracks, which has led to erosion and down-slope deposition in places. Other than identified areas of possible sediment deposition and track erosion, the swamps appear to be intact and in good condition. Sections of both swamps show defined watercourses where the swamp narrows.</p> <p>Paddys Creek swamps (not shown) are lightly impacted by tracks, and appear intact and in good condition.</p> <p>Source: Wallerawang: film 1618, run R4W, frame 5213, 1:38,000</p>

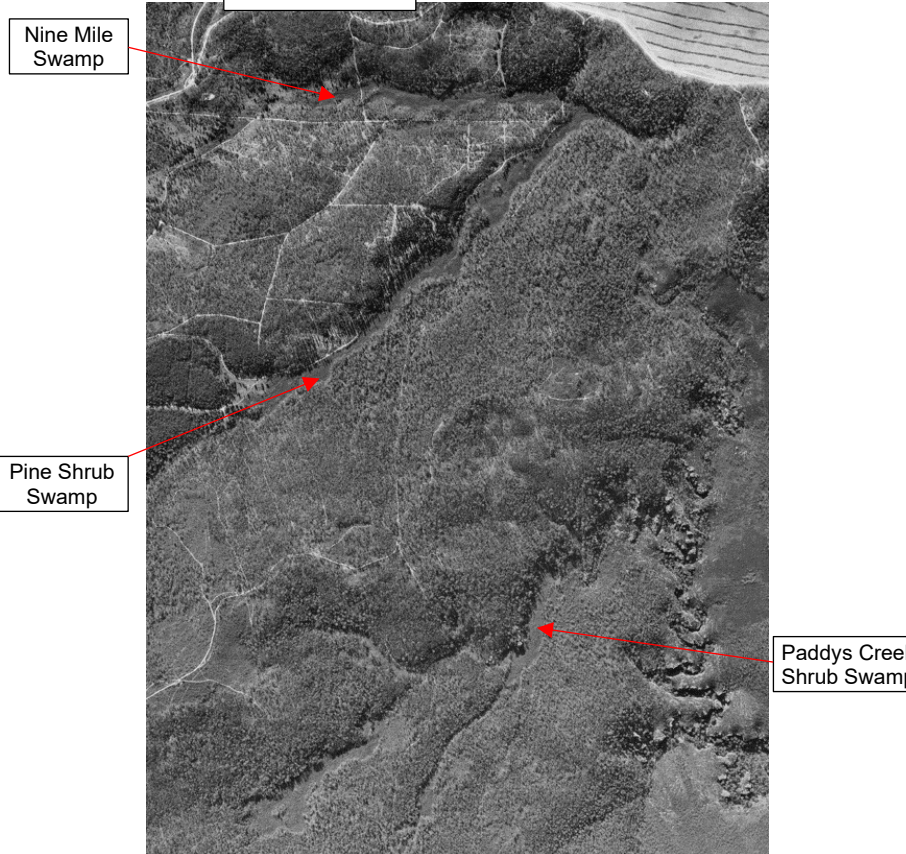
<p>Nine Mile Swamp</p> <p>Pine Shrub Swamp</p> <p>Paddys Creek Shrub Swamp</p>	<p>May 1975</p> <p>Major forestry clearance is occurring to the north.</p> <p>Continued development of tracks and forestry areas is occurring.</p> <p>Channels within the upper section of Nine Mile and Pine Shrub Swamps are better defined.</p> <p>Paddys Creek Swamp and tributaries appear intact, with little obvious adverse impact.</p> <p>Source: Wallerawang: film 2315, run R3W, frame 179, 1:40,000</p>

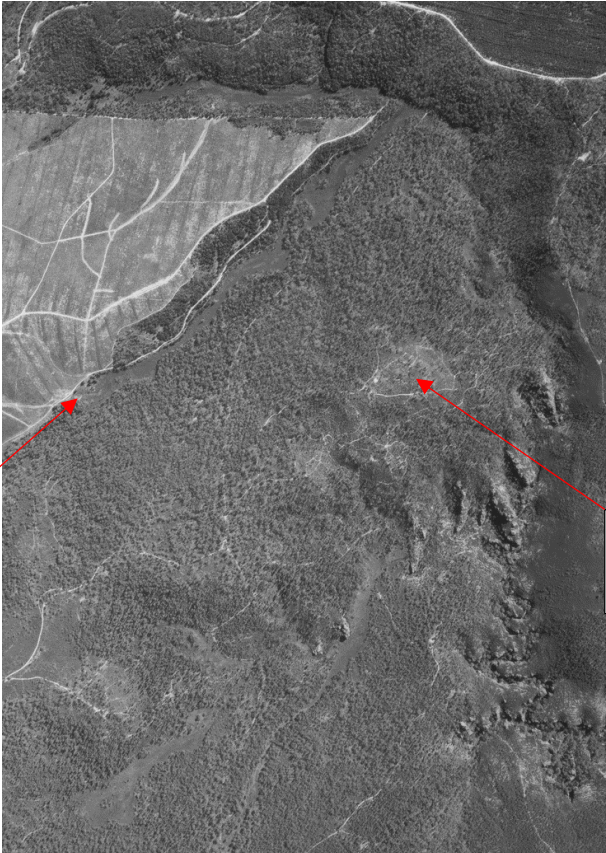
<p data-bbox="172 685 316 786">Sediment migration into head of Pine Shrub Swamp</p> <p data-bbox="938 723 1098 824">Many tracks dissecting native woodland on plateau.</p>	<p data-bbox="1118 215 1254 241">March 1984</p> <p data-bbox="1118 248 1493 360">Large swathes have been cleared for forestry on the interfluvium between Nine Mile and Pine Shrub Swamps.</p> <p data-bbox="1118 367 1493 533">Many tracks dissect the plateau areas, particularly in and adjacent to Pine Hanging Swamp, and crossing the head of Paddys Creek Swamp and at the Nine Mile / Pine Swamp confluence.</p> <p data-bbox="1118 539 1493 622">Sediment appears to have migrated from a track into the upper section of Pine Swamp.</p> <p data-bbox="1118 629 1493 689">Source: Wallerawang, Film 3377, run R11, Frame 56, 1:25,000</p>

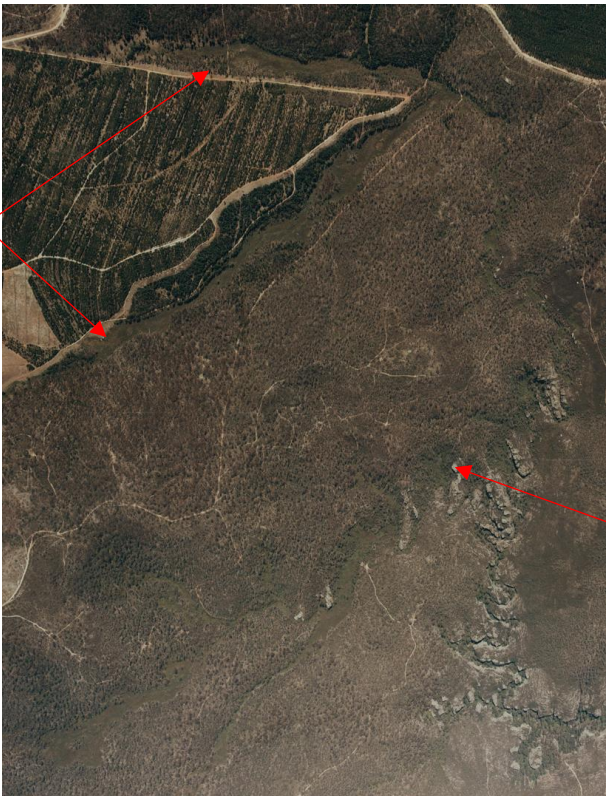
<p data-bbox="172 1252 316 1352">Sediment inputs from cleared areas and tracks</p> <p data-bbox="959 1585 1082 1637">Many fallen trees</p>	<p data-bbox="1118 1081 1302 1108">September 1991</p> <p data-bbox="1118 1115 1493 1227">Area appears dry, with sparse woodland and thinning swamp vegetation in places (drought commenced in this year).</p> <p data-bbox="1118 1234 1493 1346">Sediment inputs to head of Pine Swamp and margins of the upper sections of Nine Mile Swamp from cleared forestry areas / tracks.</p> <p data-bbox="1118 1352 1493 1487">Appear to be many fallen trees within and adjacent to the Paddys Creek and Lower Nine Mile Hanging Swamps, in the area shown.</p> <p data-bbox="1118 1494 1493 1554">Source: Wallerawang, Film 4041, run R11, Frame 122, 1:25,000</p>

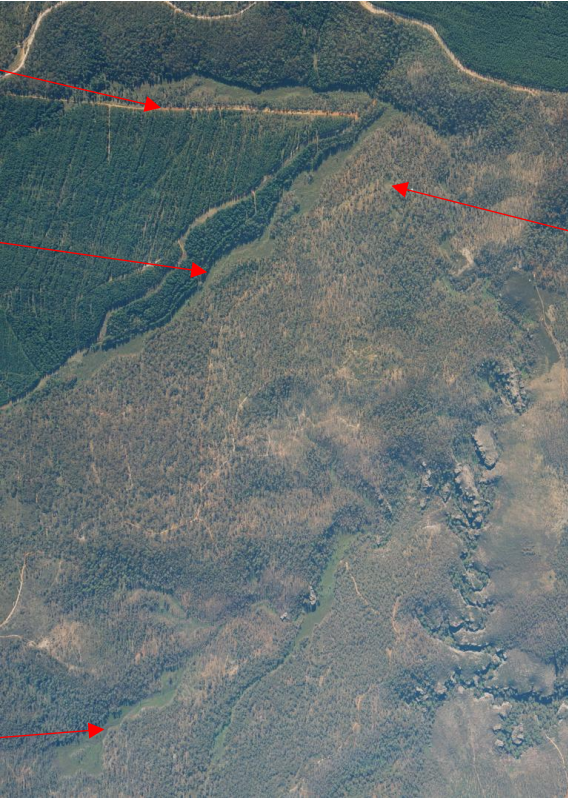
<p data-bbox="172 241 331 320">Eroding iron-rich sediment along track</p> <p data-bbox="172 398 331 499">Sections of Pine Shrub Swamp have distinct channel</p> <p data-bbox="172 891 331 992">Upper Paddys Creek Swamp has distinct channel</p> <p data-bbox="938 421 1090 477">Pine Hanging Swamp</p>	<p data-bbox="1118 212 1238 241">June 1998</p> <p data-bbox="1118 248 1485 360">Vegetation coverage and density has improved since 1991. Swamp condition appears to have improved.</p> <p data-bbox="1118 367 1501 501">Distinct channels can be observed within upper Paddys Creek swamp and sections of Pine Shrub Swamp. Pine Hanging Swamp is clearly visible for the first time.</p> <p data-bbox="1118 508 1477 564">Tracks show iron oxidisation (red staining) and erosion.</p> <p data-bbox="1118 571 1477 627">Source: Wallerawang, Film 4437, run R11, Frame 214, 1:25,000</p>

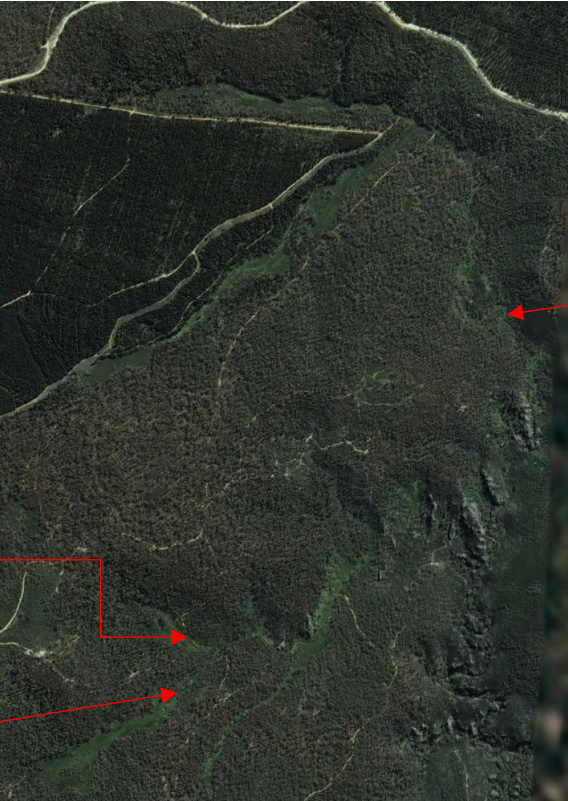
<p data-bbox="183 1529 335 1630">Track through Upper Paddys Creek Swamp is enlarged</p> <p data-bbox="183 1686 335 1787">Upper Paddys Creek Swamp has distinct channel</p> <p data-bbox="943 1283 1094 1384">Lower Nine Mile Swamp has distinct channel</p>	<p data-bbox="1118 1023 1254 1052">March 2002</p> <p data-bbox="1118 1059 1501 1137">Swamps appear to be in good condition, with recovery of previous erosion.</p> <p data-bbox="1118 1144 1493 1279">Swamps appear intact, other than the upper section of Paddys Creek Shrub Swamp and the narrow gorge sections of Lower Nine Mile Swamp.</p> <p data-bbox="1118 1285 1414 1314">Source: Google Earth 2023</p>

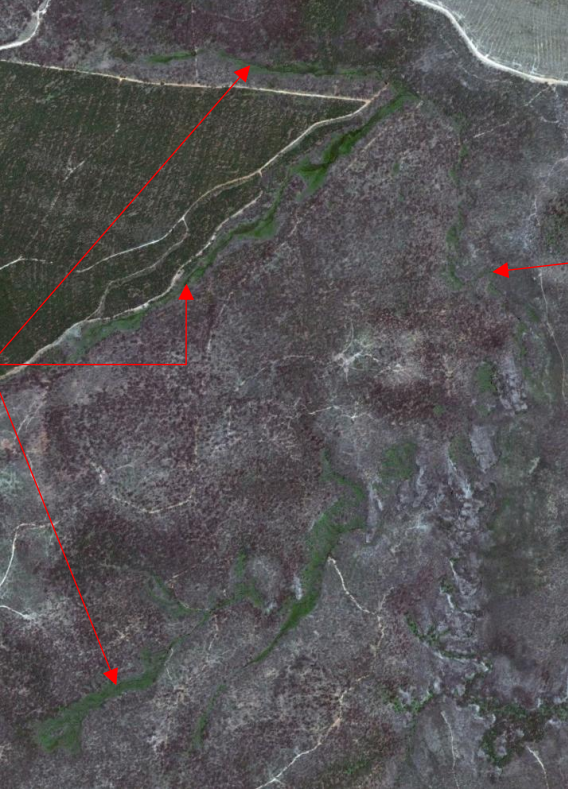
<p data-bbox="177 533 331 607">Clearly defined channels in all creeks</p> <p data-bbox="930 432 1085 528">Lower Nine Mile Swamp has distinct channel</p>	<p data-bbox="1118 215 1299 241">November 2014</p> <p data-bbox="1118 248 1501 443">Riparian and interfluvial areas appear denuded of vegetation, and it is assumed that this area was affected by the 2013 fires. The swamps, therefore, stand out clearly, indicating their resilience due to their ability to retain water.</p> <p data-bbox="1118 450 1493 533">Flow within the swamps is flowing within well-defined single / multiple channels and broader swales.</p> <p data-bbox="1118 539 1501 703">Morphology appears to indicate temporary transition to channelised fill-type swamp. Channels were still visible in 2016, but swamps appear to have reverted to intact-type by 2019.</p> <p data-bbox="1118 710 1414 741">Source: Google Earth 2023</p>

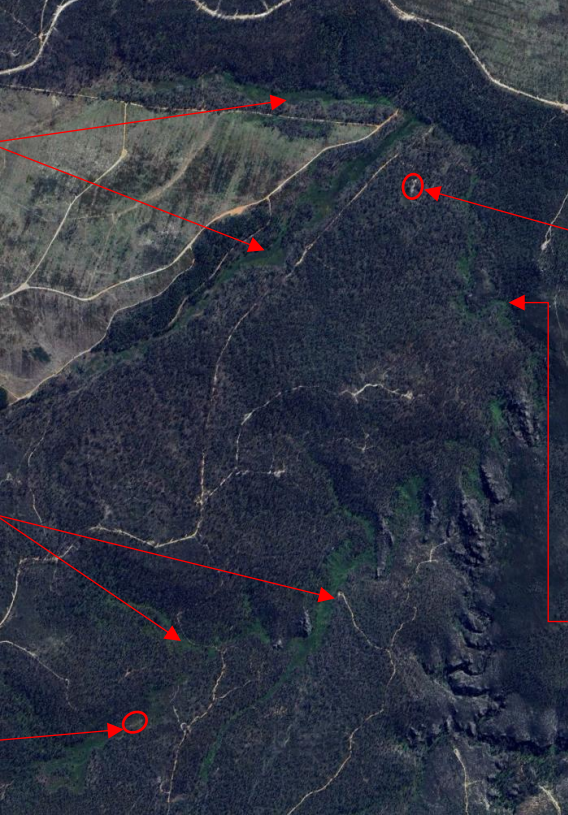
<p data-bbox="177 1099 331 1227">Intact swamps with diffuse flow patterns and dense vegetation</p> <p data-bbox="177 1491 331 1592">Channelised flow in Paddys Creek tributary and lower Swamp</p> <p data-bbox="177 1704 331 1805">Eroding area in upper section of Paddys Creek Swamp</p> <p data-bbox="930 1178 1085 1323">Eroding area of downstream section of Pine Hanging Swamp associated with track erosion.</p> <p data-bbox="930 1592 1085 1693">Lower Nine Mile Swamp has distinct channel</p> <p data-bbox="999 1391 1153 1447">Areas of poor recovery</p> <p data-bbox="999 1469 1153 1570">Eroding area in upper section of Paddys Creek Swamp</p> <p data-bbox="999 1749 1153 1895">Eroding area of downstream section of Pine Hanging Swamp associated with track erosion.</p>	<p data-bbox="1118 1021 1305 1048">September 2023</p> <p data-bbox="1118 1055 1493 1189">Swamps show rapid recovery after 2019 / 2020 fire. Pine and Nine Mile Swamps appear intact, with evidence of dispersed flow and good vegetation cover.</p> <p data-bbox="1118 1196 1477 1361">Upper Paddys Creek Swamp shows some damage, with areas showing slower recovery and a broad area of erosion / sediment deposition (indicated and shown below).</p> <p data-bbox="1118 1581 1469 1682">Track erosion appears to have headcut into the lower section of Pine Hanging Swamp (shown below).</p>

It was not possible to verify the erosion observed on aerial photographs within the lower section of Pine Hanging Swamp. However, track erosion was observed in the area, and the imagery clearly shows erosion.

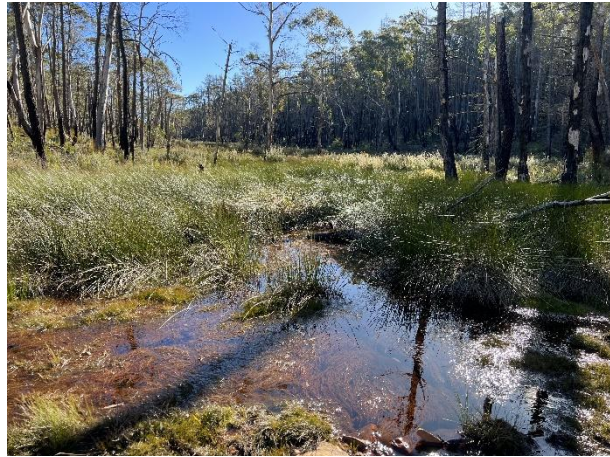
7182

View upstream of densely vegetated Nine Mile Swamp, S_UID and channel, with water pooled on track at site 17. Track has been repaired with angular cobbles.

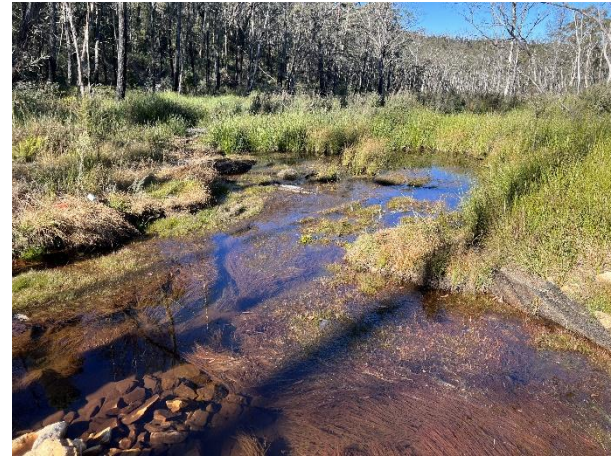
7183

View downstream of pooled water entering much smaller natural channel in Pine Swamp S_UID 184. Note in-channel vegetation.

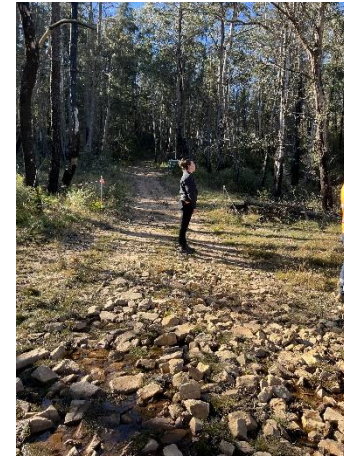
7184

View of left bank, where repaired track enters watercourse.

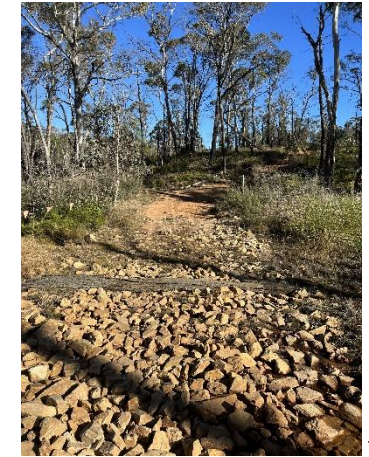
7185

View of right bank, showing broad pooled water and repairs to track with angular cobbles and jute erosion matting.
