918 Panel Watercourse Stability and Geomorphological Assessment Clarence Colliery

Clarence Colliery Pty Ltd

14 January 2026

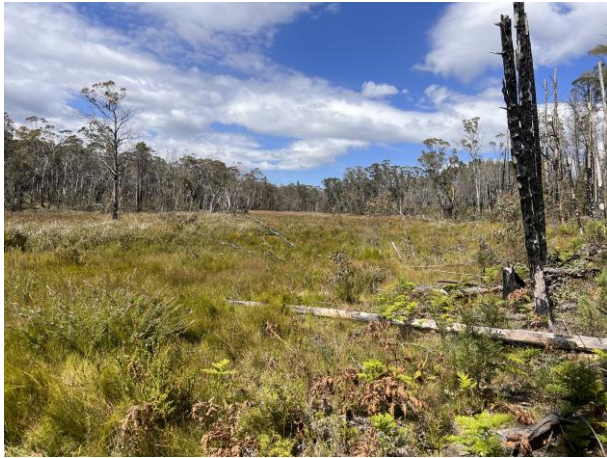
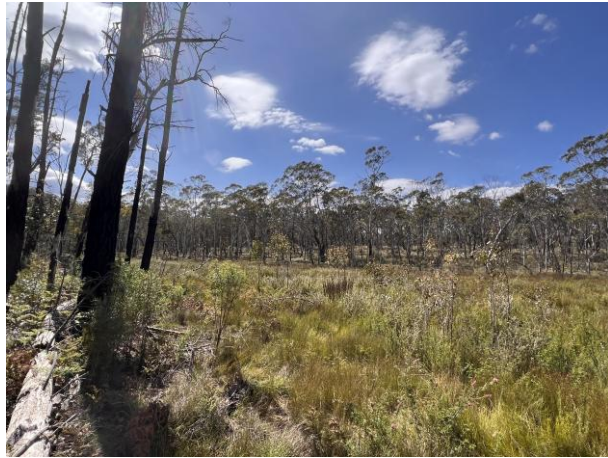
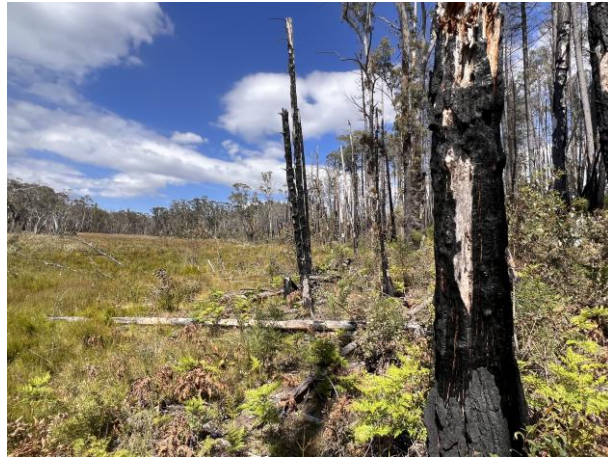
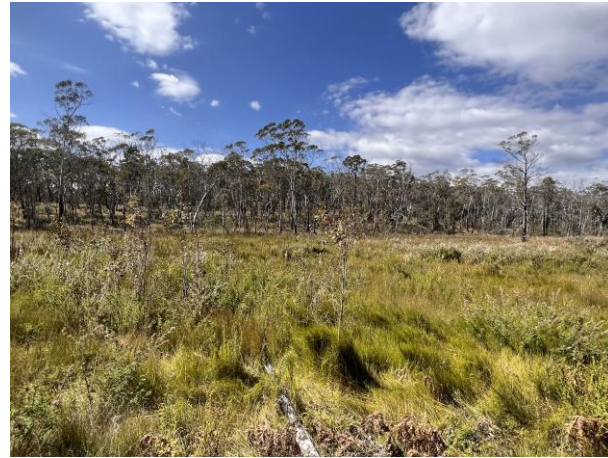
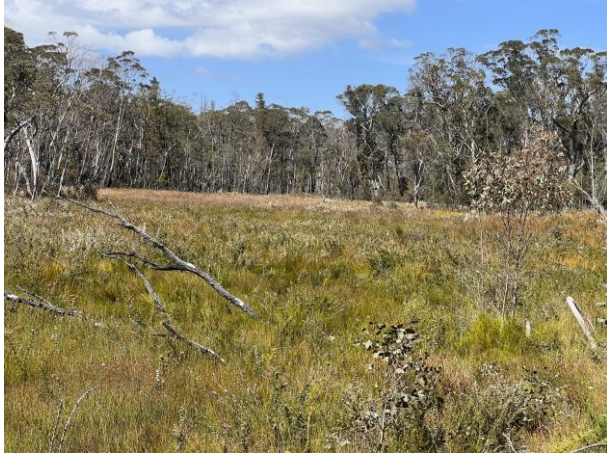
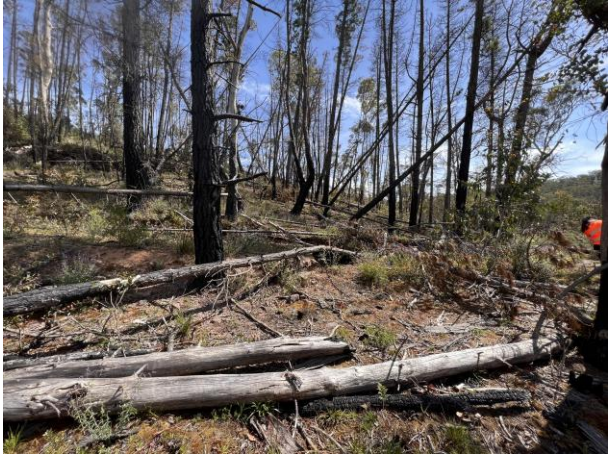
Towards right bank, at star picket	Looking northwest	Track erosion	Fire-damaged hillside
November 2023			
View southeast across Pine Shrub Swamp, S_UID 184, showing dense vegetation at site 24	View northwest at severely burned hillside above left margin of swamp S_UID 184 at site 24	Minor erosion in edge of former track, above left margin of swamp S_UID 184 at point 25	Severely burned forest / hillside above left margin of swamp S_UID 184 at site 23
  <p data-bbox="626 701 676 722">9382</p>	  <p data-bbox="1314 701 1365 722">9383</p>	  <p data-bbox="2122 701 2172 722">9384</p>

Upstream	Downstream	Left swamp margin	Right swamp margin
View upstream across Pine Shrub Swamp, S_UID 184	View downstream across Pine Shrub Swamp, S_UID 184	Dense, good condition swamp vegetation contrasting with severely fire-damaged hillside above. Close-up of waterlogged, muddy ground.	Dense swamp vegetation with slightly fire-damaged forest above swamp S_UID 184.
  <p data-bbox="747 1278 798 1299">9371</p>	  <p data-bbox="1433 1278 1484 1299">9372</p>	  <p data-bbox="2122 1278 2172 1299">9373</p>	  <p data-bbox="2810 1278 2861 1299">9374</p>
		  <p data-bbox="2000 1724 2050 1745">9375</p>

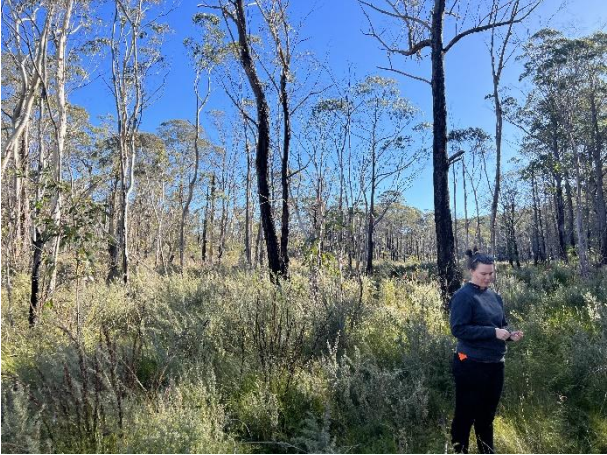
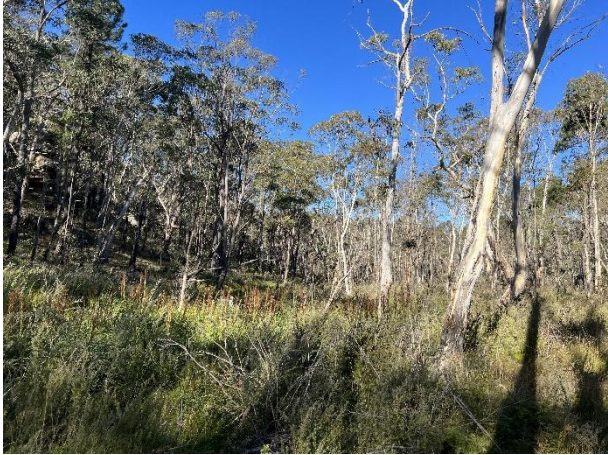
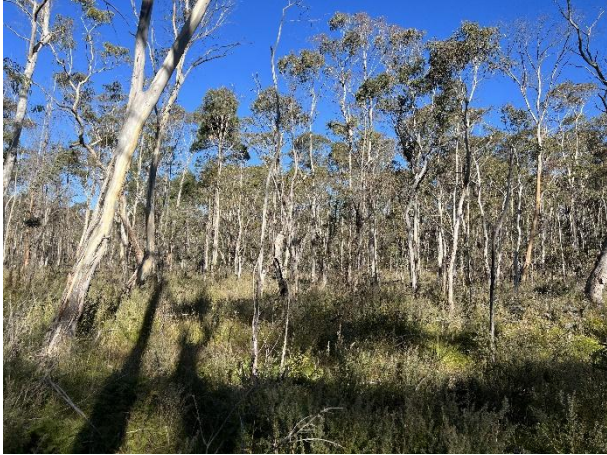
Track approx. 40 m upstream of BC1, at site 16			
View upstream of densely vegetated Pine Swamp, S_UID 184, and water pooled on track. Track has been repaired with angular cobbles.	View downstream of pooled water entering much smaller natural channel. Note in-channel vegetation.	View of left bank, where repaired track enters watercourse.	View of right bank, showing broad pooled water and repairs to track with angular cobbles and jute erosion matting.
  <p data-bbox="750 1761 801 1782">7178</p>	  <p data-bbox="1436 1761 1486 1782">7181</p>	  <p data-bbox="2003 1761 2053 1782">7179</p>	  <p data-bbox="2691 1761 2742 1782">7180</p>
Main track approx. 220m upstream of BC1

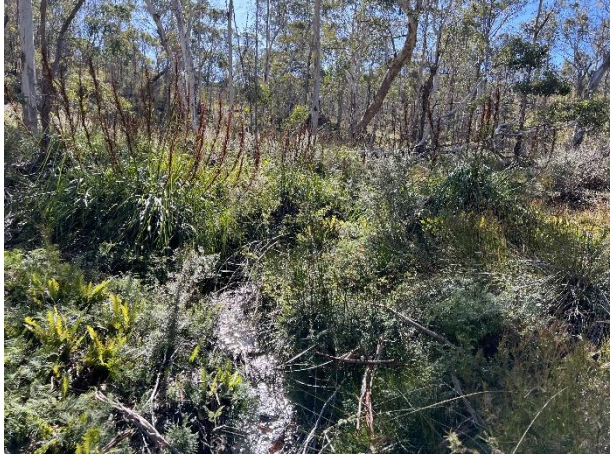
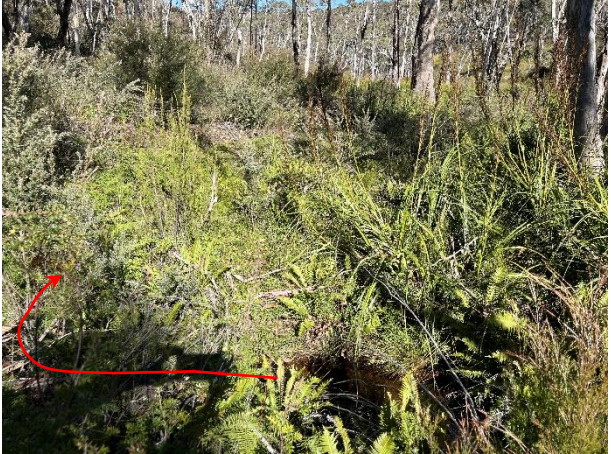
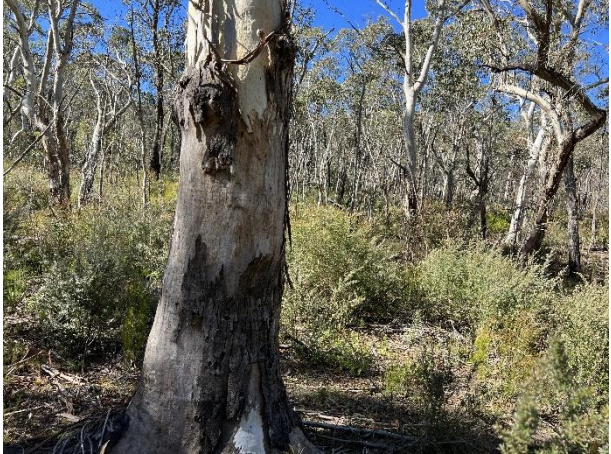
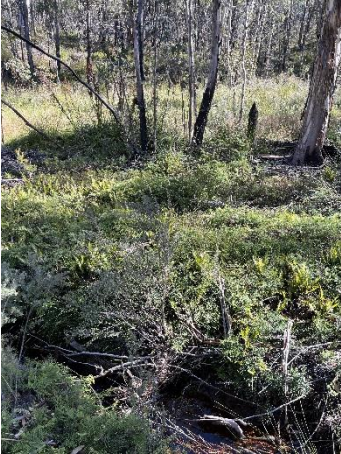
Monitoring Point / Orientation	Location	Channel characteristics	Other notes
BC2, at site 10	BC2 is located approx. 300 m upstream from an eroding fire trail at the upstream end of Lower Nine Mile Shrub Swamp, S_UID 581.	<ul style="list-style-type: none"> - Small, well-defined channel approx. 1 m wide, incised approx. 0.5 m into Lower Nine Mile Shrub Swamp, S_UID 581. - Channel meanders acutely. 	<ul style="list-style-type: none"> - Ground waterlogged in places. - Rock outcropping on right valley wall. Passed rock outcrops adjacent to creek upstream. - Flood debris had accumulated on trees approx. 2 m above creek level at time of site visit.

Upstream	Downstream	Left Bank	Right Bank
View upstream of narrow, incised channel winding through densely vegetated swamp S_UID 581 margins.	View downstream at narrow channel with wider pool at acute meander. Channel winds through densely vegetated swamp S_UID 581 margins.	View of large tree and shrub swamp S_UID 581 margins above left bank.	View over swamp S_UID 581 and right bank of channel.

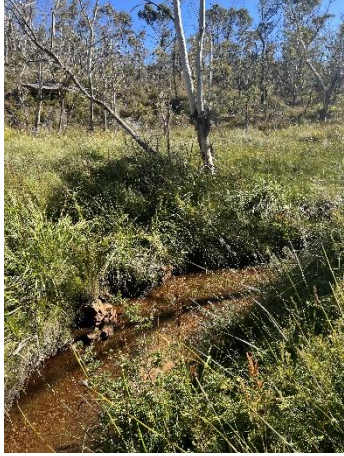
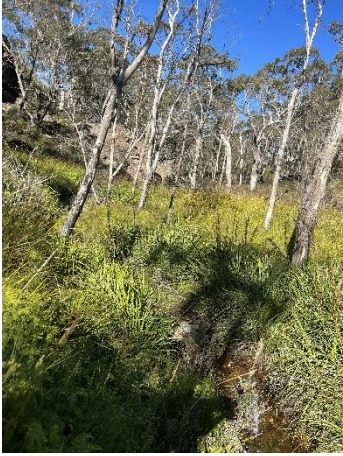
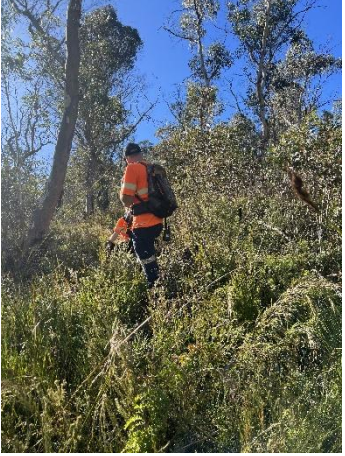
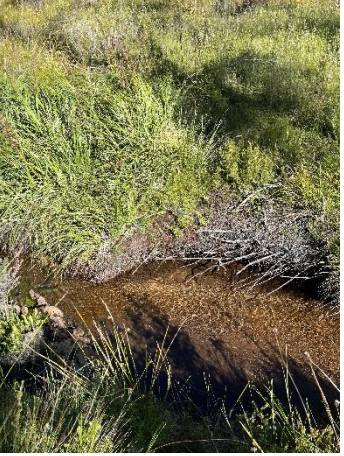
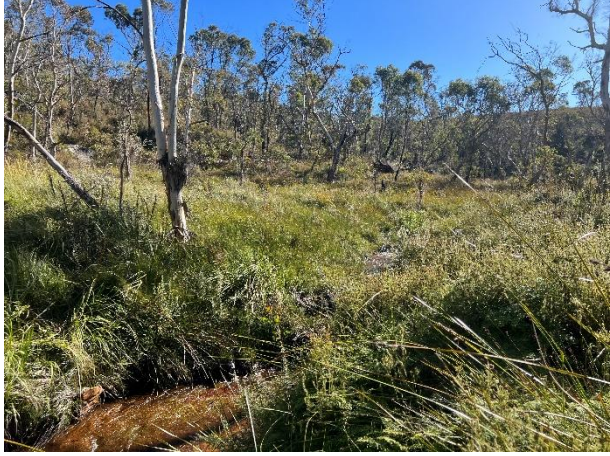
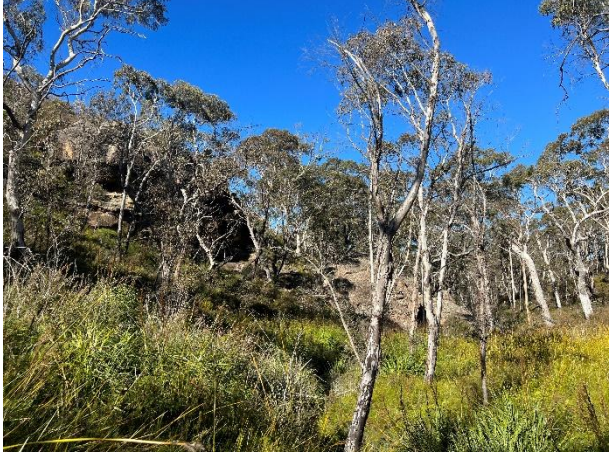
B-1-5 Lower section of Lower Nine Mile Shrub Swamp, S_UID 581

Monitoring Point / Orientation	Location	Channel characteristics	Other notes
BC3, site 11	BC3 was accessed from the firetrail and BC2, walking over the ridgeline and dropping into the valley via a gully. Located near the downstream end of Lower Nine Mile Shrub Swamp, S_UID 581, at site 11.	Small, well-defined channel approx. 1 m wide, incised approx. 0.5 m into swamp.	Ground waterlogged in places. Rock outcropping on right valley wall. Passed rock outcrops adjacent to creek upstream.
Upstream	Downstream	Left Bank	Right Bank
View upstream showing swiftly flowing, well-defined creek with bedrock outcropping in creek bed. Dense swamp vegetation within riparian corridor.	View downstream showing rock outcropping within bed of creek. Rock outcrops visible approx 50 m downstream.	View of hillside above left bank.	View of right bank and swamp beyond right bank.

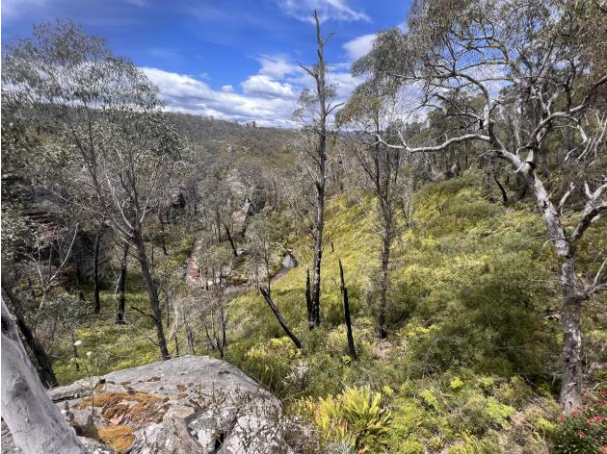
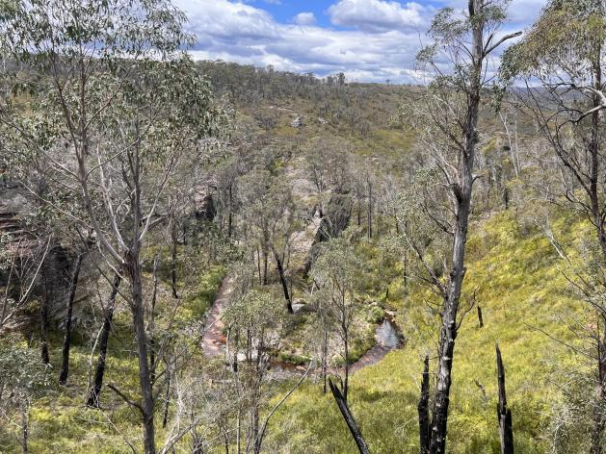
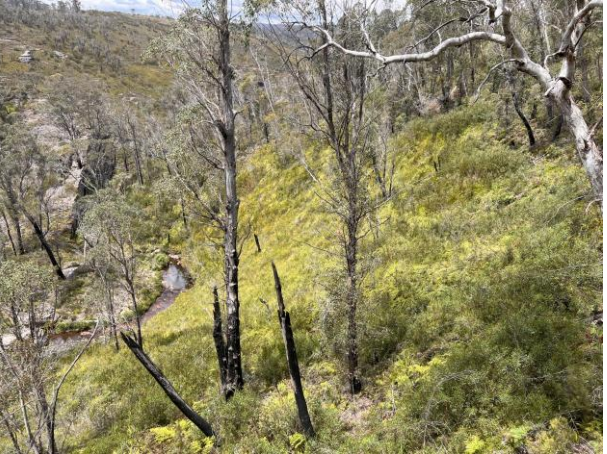
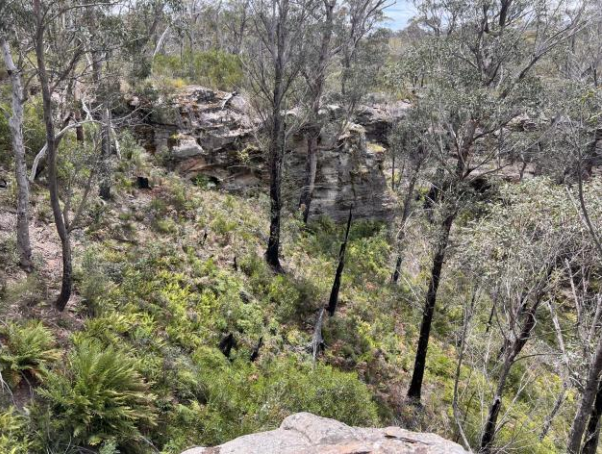
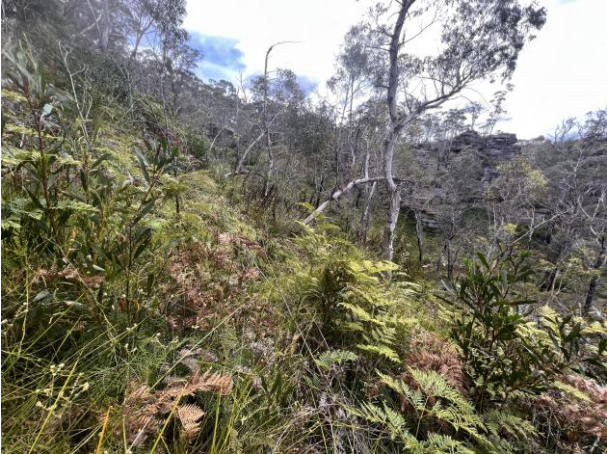
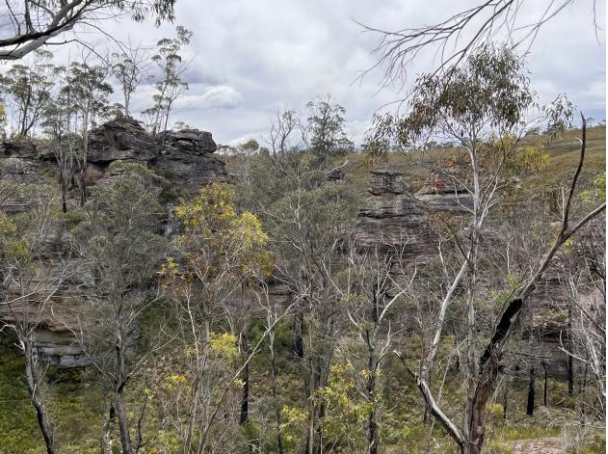
B-1-6 Lower Nine Mile Hanging Swamp, S_UID 577

Monitoring Point / Orientation	Location	Channel characteristics	Other notes
NMH_1, at site 29	NMH_1 was accessed by following a faint ridge from a subsidence monitoring point at the end of a track. There is a good vantage point from a rock outcrop to the north of swamp S_UID 577.	<ul style="list-style-type: none"> Contorted hairpin meanders around rock cores, with the creek morphology strongly structurally controlled. Meander core shows exploitation of a joint, with a sharp, straight-edged rock remnant. Creek bed is rock, with a deep pool below the hanging swamp and rock steps creating riffles. 	Hanging swamp S_UID 577 is very steep and in good condition with intact, dense vegetation.
Wide view south over swamp S_UID 577, at site 29	Swamp S_UID 577 is perched above hairpin meander around rock core.	Swamp S_UID 577	View north over rock outcropping along meander embayment
Close-up of previous photograph, showing deep pool and rock steps in creek bed, with hanging swamp S_UID 577 perched above the downstream limb of the hairpin. Sharp, straight-edged rock remnant indicates joint exploitation.	Intact, densely vegetated swamp S_UID 577 with rock outcrop above.	Rock outcropping and pagoda formations along the meander embayment upslope of hairpin.

<p>9404</p>
Southern margin of swamp S_UID 577 at site 27	Pagoda formations from site 29	Carpark at site 30, access point for swamp S_UID 577	Downslope erosion control within car park at site 30, showing recent deposition of eroded material.
Coral fern and dense hanging swamp vegetation within swamp S_UID 577 at site 27.	Access point at carpark, site 30, for swamp S_UID 577, showing recent erosion.	Downslope erosion control within car park at site 30, showing recent deposition of eroded material.

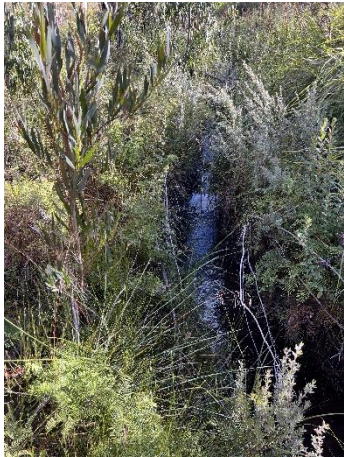
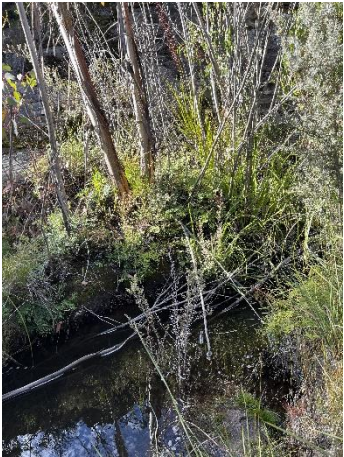
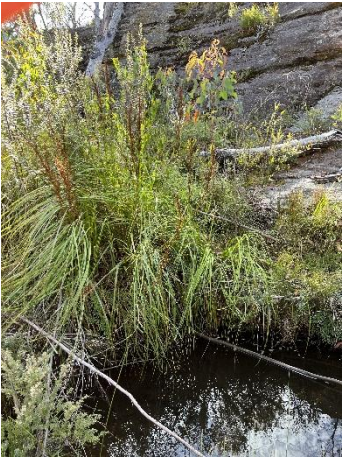
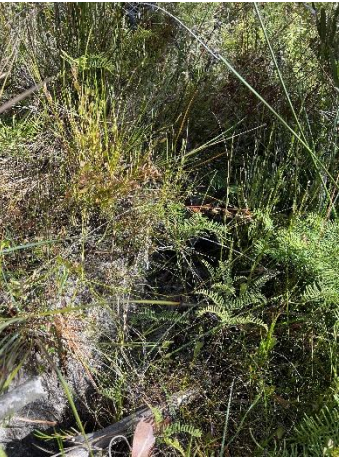
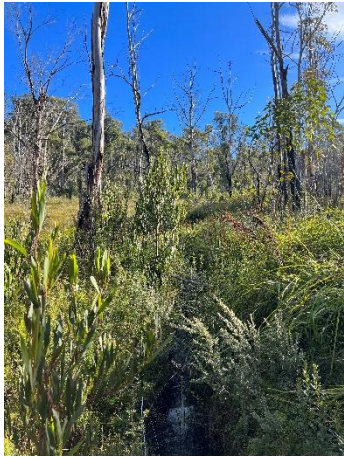
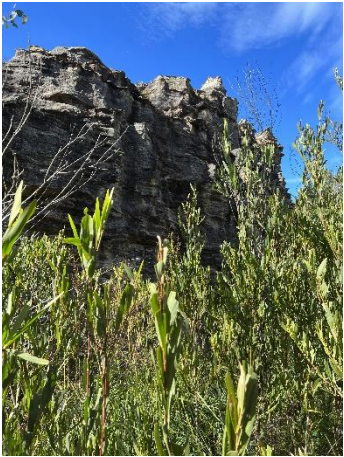
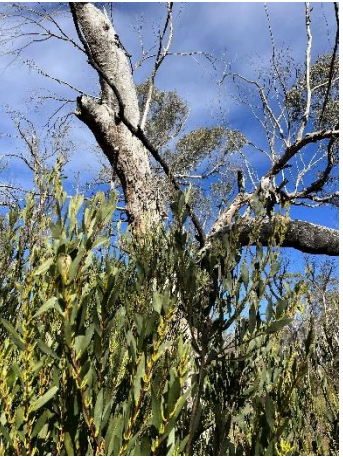
Monitoring Point / Orientation	Location	Channel characteristics	Other notes
PC1_1, site 4 PC1_2, site 5	PC1 location 1 is located at the base of the valley where safe to access, at the downstream end of Paddys Creek Shrub Swamp, S_UID 565 and upstream end of rock outcropping above the left bank, at site 4. Park at end of track and walk across dry hanging swamp to access main creek. Location PC1_2 is located adjacent to the trail end parking area, at site 5, upstream of PC1_1.	<ul style="list-style-type: none"> The channel is bedrock-controlled with small, stepped waterfalls. Flow runs along the base of a rock outcrop. Banks were sandy, with minor slumping of the right bank. Riparian corridor densely vegetated. 	
PC1_1 – adjacent to upstream end of rock outcropping and downstream end of Paddys Creek Shrub Swamp, S_UID 565 at site 4			
View upstream at narrow channel at site 4. Bedrock outcropping in channel bed, with stepped waterfalls.	View downstream at natural wider pool within channel where water draining rock outcrop enters main channel. Pagoda visible in background.	View of rock outcropping above vegetated left bank, where water draining outcrop enters to form a wider pool in the main channel.	Slumping of sandy soil along right bank of creek. Large tree marks location of monitoring point.

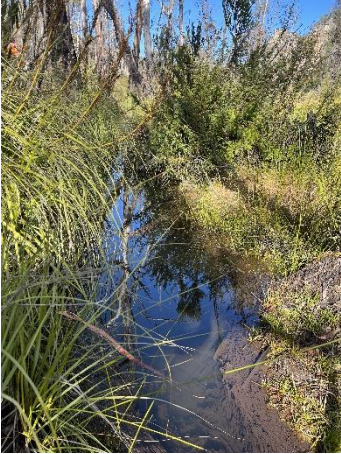
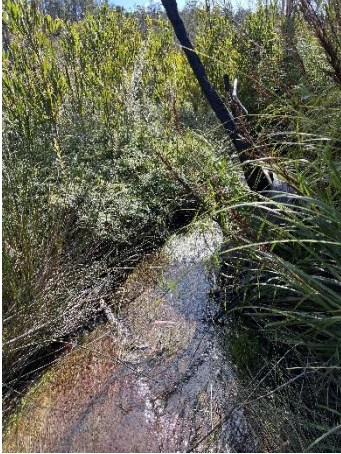
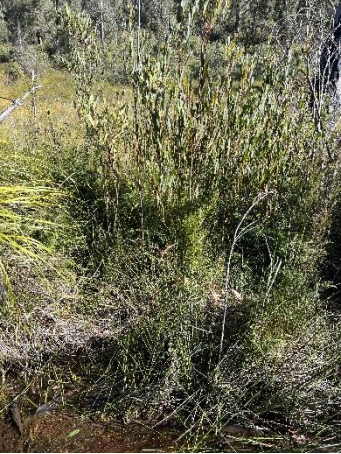
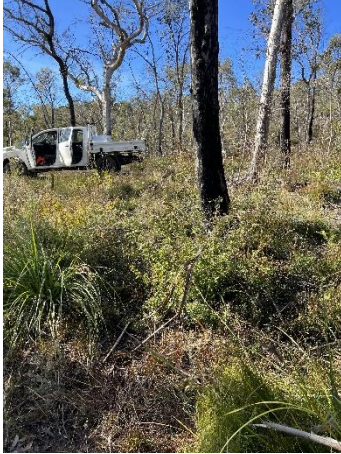
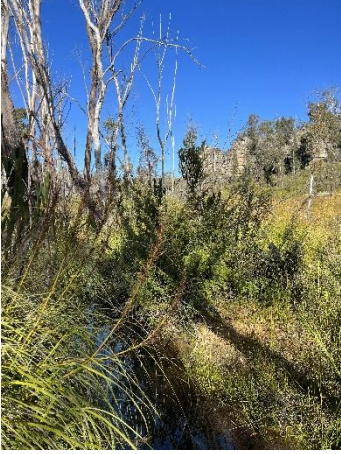
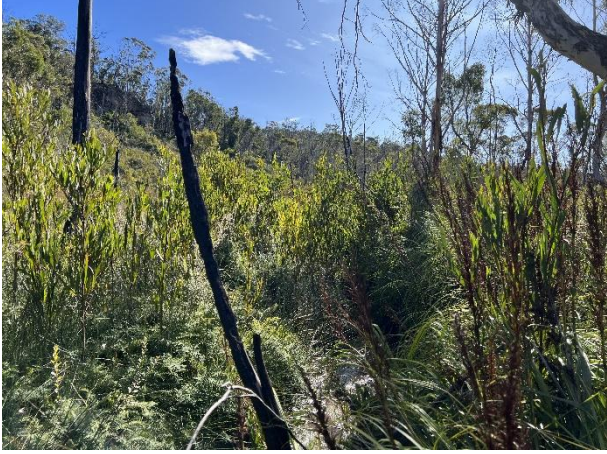
PC1_2 – adjacent to car park at site 5.			
View upstream at channel approx. 1.5m wide. Characterised by pools and riffles with in-channel vegetation. Rock outcrops visible in background.	View downstream at densely vegetated channel and riparian corridor, with good condition swamp (S_UID 565).	View across densely vegetated left bank and swamp (S_UID 565).	View of area above right bank to car parking area at trail end.

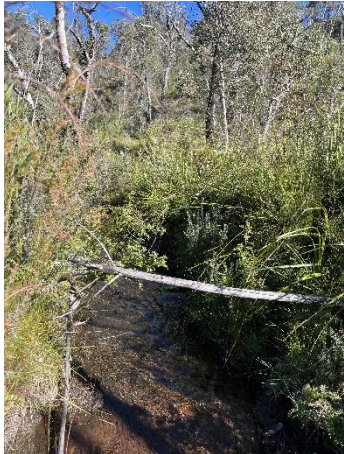
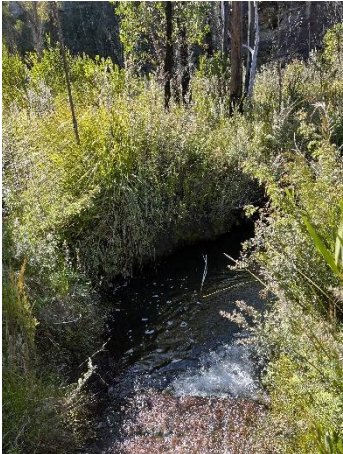
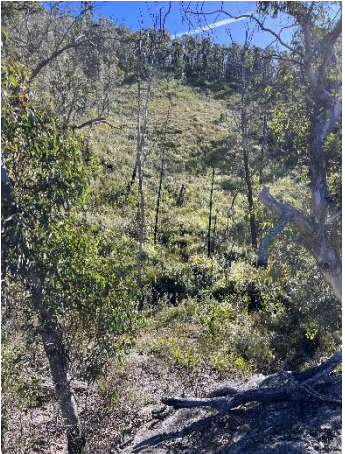
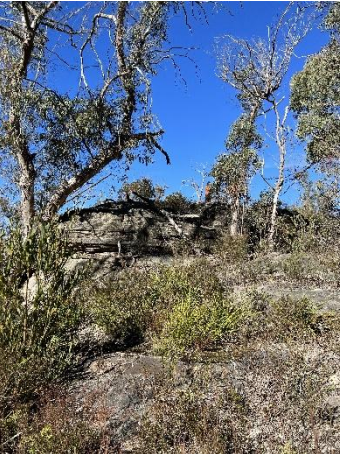
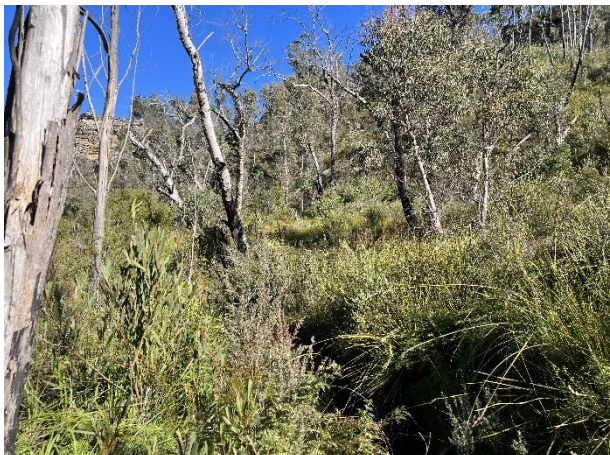
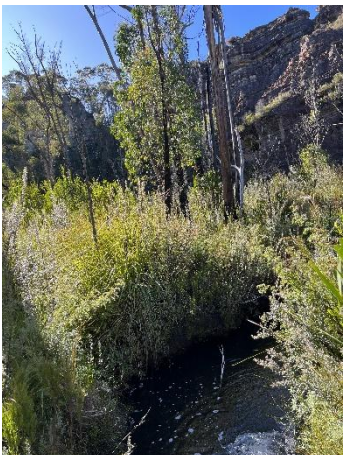
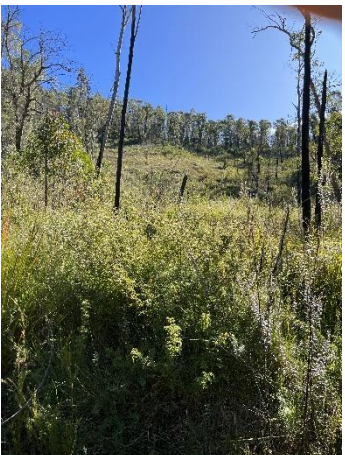
Monitoring Point / Orientation	Location	Channel characteristics	Other notes
PC2, sites 6 and 7	PC2 location is from a prominent rock outcrop overlooking Paddys Creek Hanging Swamp S_UID 564, at sites 6 and 7. The channel can be accessed safely to the left of the outcrop.	The channel is bedrock-controlled with rock steps and deeper pools. Channel is approx. 1 m - 1.5 m wide. Riparian corridor densely vegetated.	
Upstream	Downstream	Left bank and Paddys Creek Hanging Swamp, S_UID 564	Right bank
View upstream at swiftly flowing, bedrock-controlled creek, approx. 1 m-1.5 m wide. Densely vegetated banks and riparian corridor.	View downstream at rock step and deeper pool. Densely vegetated banks and riparian corridor.	Top: view across good condition, well-vegetated, steep hanging swamp (S_UID 564) from rock outcrop above creek. Bottom: view of left bank and hanging swamp (S_UID 564) from creek level.	View of rock outcrop vantage point above right bank of creek.

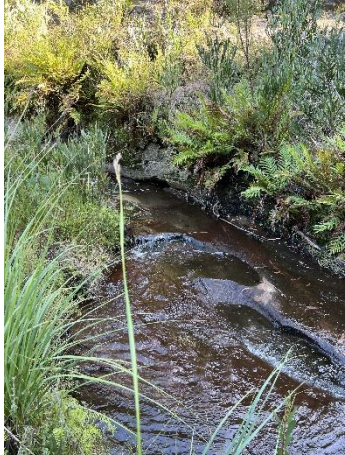
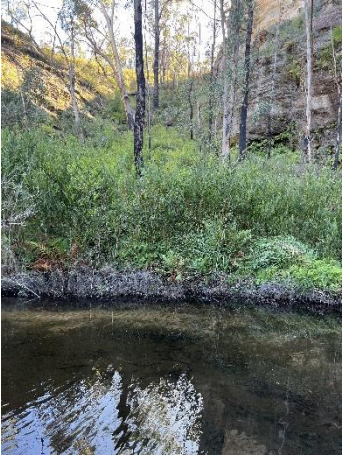
Upstream	Left Bank
View upstream at rock steps and scour holes in creek upstream of pool	View into gully above wide pool at meander apex, with sediment from gully forming a vegetated delta in break in valley side, and accumulating in pool.
